# **Self-lubricating W-S-C-Cr tribological coatings deposited by r.f. magnetron sputtering**

Joao Vitor Pimentel<sup>1\*</sup>, Manuel Evaristo<sup>2</sup>, Tomas Polcar<sup>3</sup>, Albano Cavaleiro<sup>2</sup>

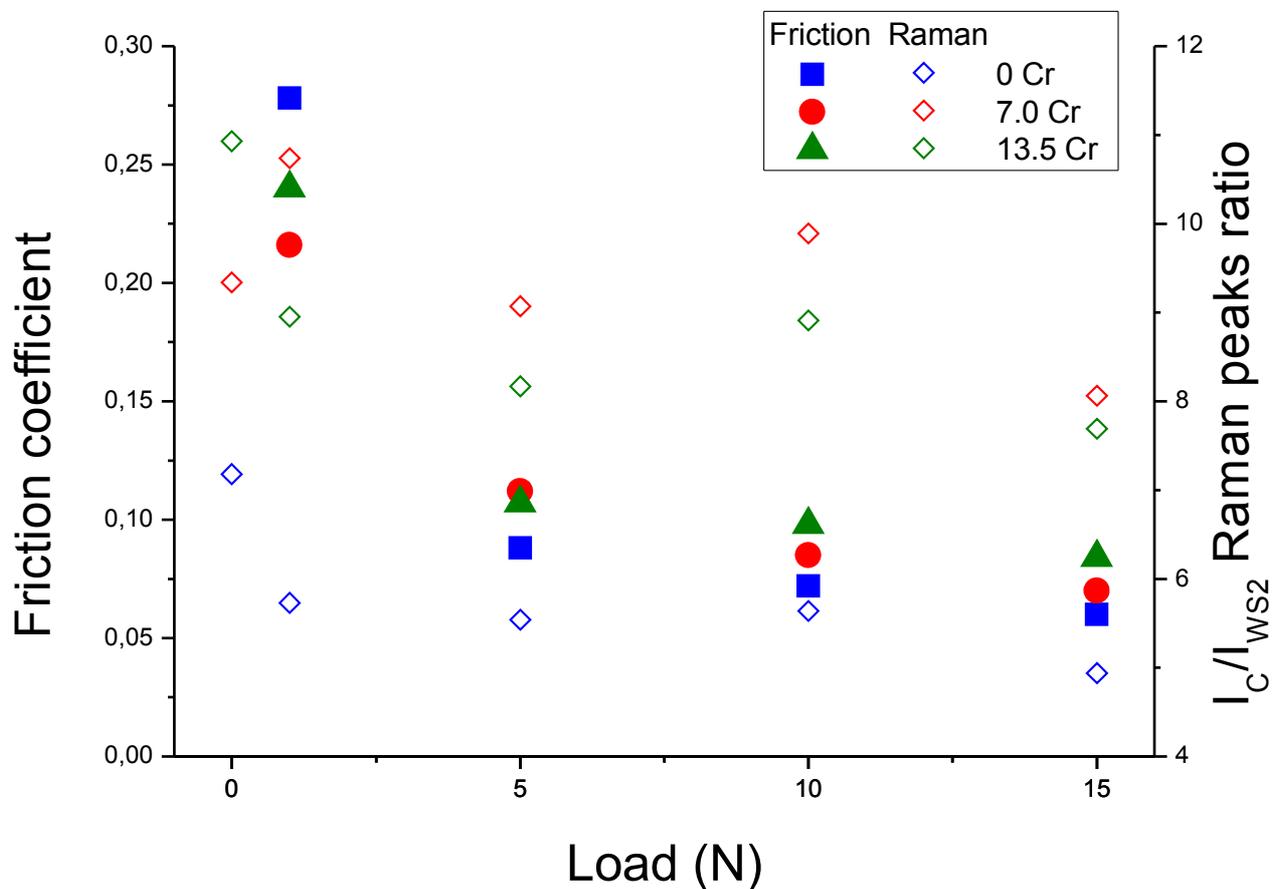
Fig. 1 Friction coefficient and Raman peak ratio for different loads

The friction coefficients decreased with increasing load, indicating that the sliding under high contact pressure leads to the formation of a TMD-rich tribolayer. Raman spectroscopy showed a clear decrease in the contribution to the spectra of peaks corresponding to carbon. Analyses of the wear tracks indicated that the tribolayer consisted mainly of amorphous tungsten and chromium oxides with platelets of WS<sub>2</sub> in small areas. Below the outermost surface, however, a thin layer of well oriented WS<sub>2</sub> was found at the interface between tribolayer and coating [3].
